**Flood Control Project Maintenance
Levee Inspections**
LMA District Cover Sheet
Spring 2019 Levee Inspection Results

Reclamation District No. 0070 Meridian

Spring 2019 Levee Inspection Results

Waterway			Bank	Unit Miles
Unit No. 01 Sutter Bypass			Right	7.92
	Spring (March - May)	Summer (June - August)	(September - November) Fall	Winter (December - February)
Unit Maintenance Rating (Fall Only)				
Date of Inspection	4/2/2019 - 4/2/2019			
DWR Inspector	Makar Sokol			
Accompanied By	Andy Duffey			
	Mike Engelmann

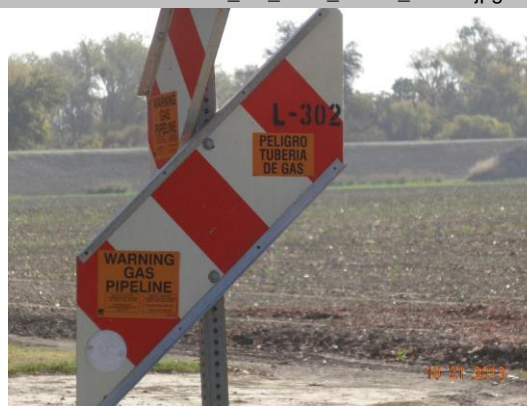
Photo 3 of 3 : UCIP_SP_2019_23384_40248.jpg

Comment Code						
Inspector Comment						
FS_ID:23384 DS_ID:21415 EP_NO: 15936 Repair Type: Non-Urgent Crossing Status: Indicator Found UCIP Comments: No markers visible on levee slope or levee toe to indicate line crosses levee. Need to contact PG&E to confirm location through levee. Also need to confirm the emergency contact person for this crossing. FIELD_STRUCT_DESC: 8-inch steel natural gas pipeline through the levee, 2.5 feet below the crown. Gas line markers on the landside (LS). (Plans to remove an existing 16-inch pipe and install an 8-inch natural gas pipe to existing pipe within the 10-foot LS limits of the levee authorized under Permit No. 15936, 1992 - Pacific Gas and Electric Company [PG&E]). FS Date: 10/21/2013

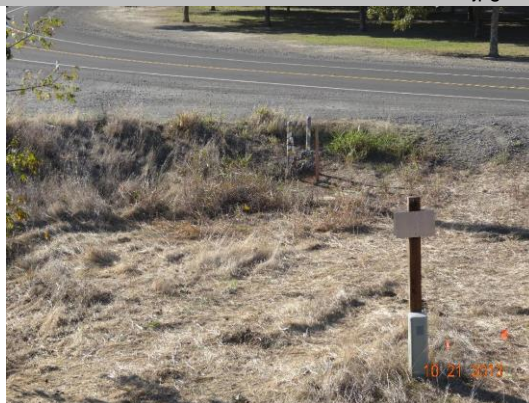
Photo 2 of 3 : UCIP_SP_2019_23467_40641.jpg

Comment Code					
Inspector Comment					
FS_ID:23467 DS_ID:21354 EP_NO: 14802 Repair Type: Non-Urgent Crossing Status: Indicator Found UCIP Comments: Need to contact owner to determine status of crossing. Need date of last inspection and confirmation that crossing is still in operable condition. Markers found about 159 feet upstream of coordinates at the crossing of the ramp and S. Tarke Road (39.142684, -121.842685). FIELD_STRUCT_DESC: 4-inch steel natural gas pipeline through the levee, 2.5 feet below the crown. Aluminum pipe marker on the landside (LS) slope. Emergency contact information for Pacific Gas and Electric Company (PG&E): (800) 344-4749? or 4742? or (916) 742-3251. (Plans to replace an existing 3-inch natural gas main through the levee with a new 4-inch steel pipe authorized under Permit No. 14802, 1987 - PG&E). [Additional Reference(s): DWR Levee Log, 2007]. FS Date: 10/21/2013

Additional appurtenances for gas line located at landward side near S. Tarke Rd.

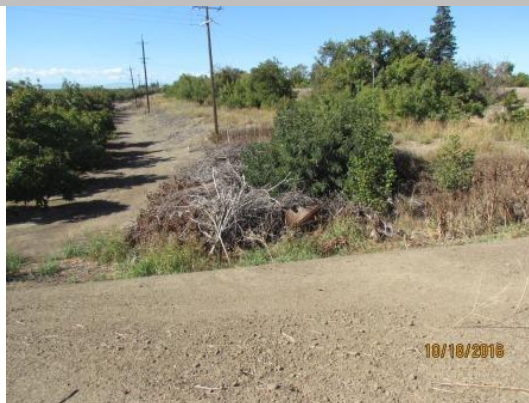
Photo 1 of 1 : SP_2019_RD0070_29_33_20190326_00008.jpg

LM Start	0.75	Rating **	M	Issue No.	33
LM End	0.75	Issue Type +	En	Location *	LS
Category	Earthen Levee			GPS Latitude/Longitude	
				Start	End
Item	Encroachments			39.145095 °	39.145095 °
				-121.842865 °	-121.842865 °
DWR ID	DWR_RD0070_01_f_2016_33				
Comment Code					
PR : Prunings					
Inspector Comment					
Prunings should be removed from the landside toe.

View of the prunings along the landside toe.

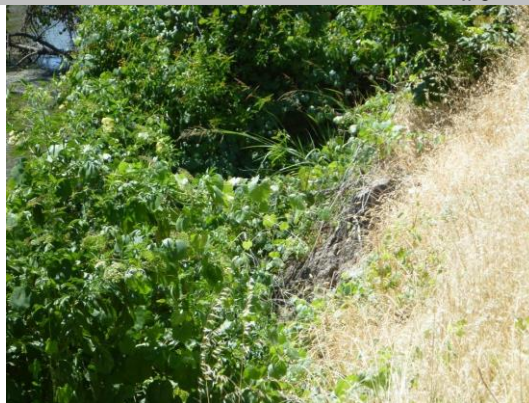
LM Start	0.76	Rating **	A/W	Issue No.	36
LM End	0.76	Issue Type +	Ma	Location *	WS
Category	Supplemental			GPS Latitude/Longitude	
				Start	End
Item	2017 Storm Damage			39.145240 °	39.145240 °
				-121.842650 °	-121.842650 °
DWR ID	DWR_RD0070_01_f_2017_36				
Comment Code					
Inspector Comment					
Levee Evaluation Comments					
Description:					
Site ID No:154					
Site Designation:RD 70-03					
Repair Type: Erosion					
Rating:Area of Concern					
Field Date:7/17/2017					
Notes:

LM Start	0.76	Rating **	A/W	Issue No.	36 (cont)	
LM End	0.76	Issue Type +	Ma	Location *	WS	
Category	Supplemental			GPS Latitude/Longitude		
				Start	End	
Item	2017 Storm Damage			39.145240 °	39.145240 °	
				-121.842650 °	-121.842650 °	
DWR ID	DWR_RD0070_01_f_2017_36					
Comment Code						
Inspector Comment						
Levee Evaluation Comments						
Description:						
Site ID No:154						
Site Designation:RD 70-03						
Repair Type: Erosion						
Rating:Area of Concern						
Field Date:7/17/2017						
Notes:

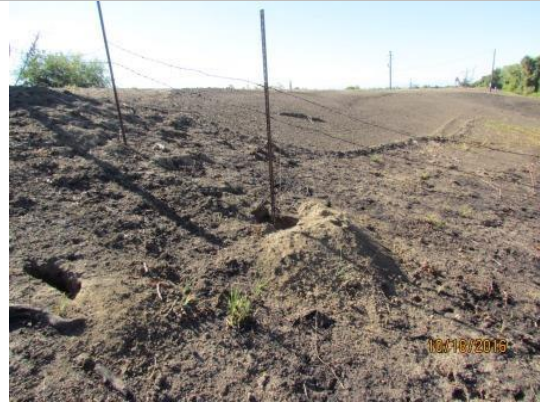
Photo 1 of 1 : SP_2019_RD0070_29_32_20190326_00007.jpg

LM Start	1.77	Rating **	M	Issue No.	32
LM End	1.77	Issue Type +	Ma	Location *	WS
Category	Earthen Levee			GPS Latitude/Longitude	
				Start	End
Item	Animal Control			39.151282 °	39.151282 °
				-121.855818 °	-121.855818 °
DWR ID	DWR_RD0070_01_f _ 2016_32				
Comment Code					
A1 : Exterminate rodents and backfill and compact or grout burrows.					
Inspector Comment

View of the rodent holes along the waterside slope.

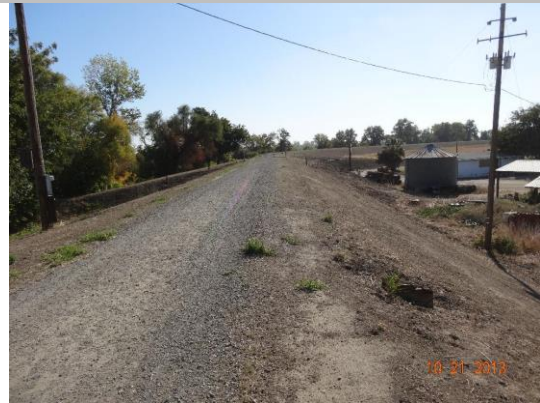
Photo 1 of 3 : UCIP_SP_2019_23508_40821.jpg

Comment Code						
Inspector Comment						
FS_ID:23508						
DS_ID:21336						
EP_NO: N/A						
Repair Type: Non-Urgent						
Crossing Status: Found						
UCIP Comments: Need to find owner to determine if crossing is still in use. If crossing is no longer in use owner will need to coordinate with DWR inspector and CVFPB to remove according to Title 23 requirements. Evidence of high burrow activity on waterward side recommend addressing issue. This crossing is referenced as USACE_CESPK_MRD1_2012_p_0230 in the USACE's PI report for no USACE recommendation letter available -- correction pipe is 12-inch not 16-inch.						
FIELD_STRUCT_DESC: 12-inch irrigation discharge pipe of an unknown material through the levee, 4 feet below the crown. Siphon breaker on the landside (LS) slope. 7-foot by 9-foot concrete distribution box at the LS toe. Service pole on the waterside (WS) slope. Pump on a concrete sump on the WS slope. Overhead power line crosses the levee. (Plans for the installation of a 12-inch steel irrigation pipe through the levee authorized under Permit No. 613, 1934 - Waldo M. Nall. Plans to retain a 12-inch pipe through the levee, 4 feet below the crown, pump, and siphon breaker authorized under Automatic Board Order (ABO) issued as Permit No. 9948, 1974 - Edward E. and Doris M. Nall). [Additional Reference(s): DWR Levee Log, 2007].

View of levee crown looking upstream from crossing.

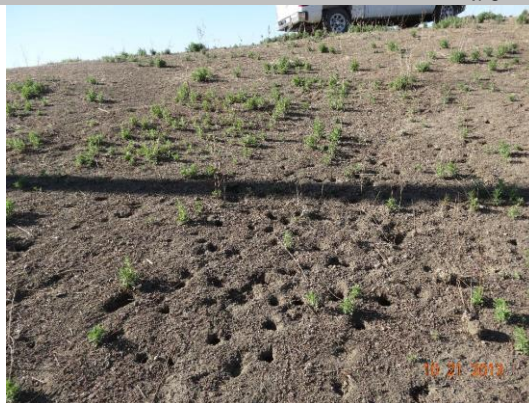
Photo 2 of 3 : UCIP_SP_2019_23508_40819.jpg

Comment Code						
Inspector Comment						
FS_ID:23508						
DS_ID:21336						
EP_NO: N/A						
Repair Type: Non-Urgent						
Crossing Status: Found						
UCIP Comments: Need to find owner to determine if crossing is still in use. If crossing is no longer in use owner will need to coordinate with DWR inspector and CVFPB to remove according to Title 23 requirements. Evidence of high burrow activity on waterward side recommend addressing issue. This crossing is referenced as USACE_CESPK_MRD1_2012_p_0230 in the USACE's PI report for no USACE recommendation letter available -- correction pipe is 12-inch not 16-inch.						
FIELD_STRUCT_DESC: 12-inch irrigation discharge pipe of an unknown material through the levee, 4 feet below the crown. Siphon breaker on the landside (LS) slope. 7-foot by 9-foot concrete distribution box at the LS toe. Service pole on the waterside (WS) slope. Pump on a concrete sump on the WS slope. Overhead power line crosses the levee. (Plans for the installation of a 12-inch steel irrigation pipe through the levee authorized under Permit No. 613, 1934 - Waldo M. Nall. Plans to retain a 12-inch pipe through the levee, 4 feet below the crown, pump, and siphon breaker authorized under Automatic Board Order (ABO) issued as Permit No. 9948, 1974 - Edward E. and Doris M. Nall). [Additional Reference(s): DWR Levee Log, 2007].

Dense burrow activity found on waterward slope.

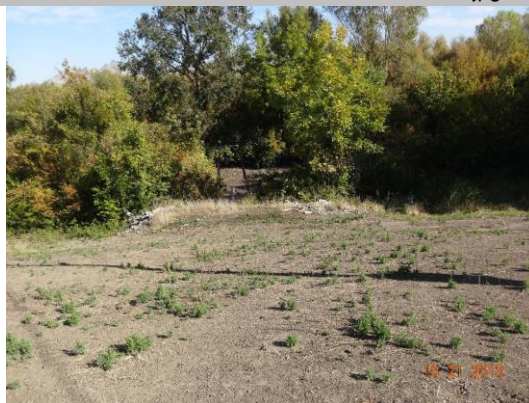
Photo 3 of 3 : UCIP_SP_2019_23508_40820.jpg

View of waterward side.

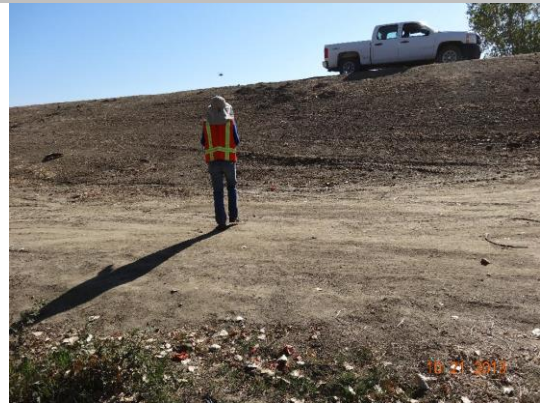
Photo 1 of 3 : UCIP_SP_2019_23506_40806.jpg

Comment Code						
Inspector Comment						
FS_ID:23506 DS_ID:21361 EP_NO: 9944 Repair Type: Non-Urgent Crossing Status: Found UCIP Comments: Burrow activity present on levee slopes. Multiple pipes found on landward side--are these pipes part of original crossing? This crossing is referenced in the USACE Periodic Inspection as item USACE_CESPK_MRD1_2012_p_0291--no USACE recommendation letter available. FIELD_STRUCT_DESC: 18-inch steel irrigation discharge pipe through the levee, 21.5 feet below the crown. Gate valve on the waterside (WS) end. Pipe discharges into a concrete box on the landside (LS). Rock revetment on the WS slope. (Retention of an 18-inch steel pipe through the levee, 21.5 feet below the crown, gate valve, and concrete box authorized under Automatic Board Order (ABO) issued as Permit No. 9944, 1974 - William J. and Marion D. Hankins). [Additional Reference(s): DWR Levee Log, 2007]. FS Date: 10/21/2013

View of waterward side slope and berm.

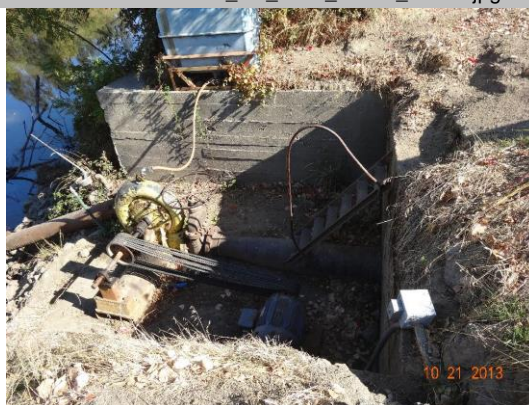
Photo 3 of 3 : UCIP_SP_2019_23506_40807.jpg

Comment Code						
Inspector Comment						
FS_ID:23506 DS_ID:21361 EP_NO: 9944 Repair Type: Non-Urgent Crossing Status: Found UCIP Comments: Burrow activity present on levee slopes. Multiple pipes found on landward side--are these pipes part of original crossing? This crossing is referenced in the USACE Periodic Inspection as item USACE_CESPK_MRD1_2012_p_0291--no USACE recommendation letter available. FIELD_STRUCT_DESC: 18-inch steel irrigation discharge pipe through the levee, 21.5 feet below the crown. Gate valve on the waterside (WS) end. Pipe discharges into a concrete box on the landside (LS). Rock revetment on the WS slope. (Retention of an 18-inch steel pipe through the levee, 21.5 feet below the crown, gate valve, and concrete box authorized under Automatic Board Order (ABO) issued as Permit No. 9944, 1974 - William J. and Marion D. Hankins). [Additional Reference(s): DWR Levee Log, 2007]. FS Date: 10/21/2013

U shaped concrete box located on waterward side contains pump, motor, stairs, and pipe.

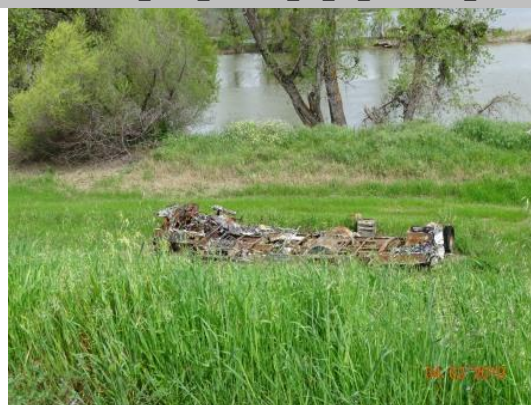
Photo 1 of 1 : SP_2019_RD0070_29_42_20190405_00074.jpg

LM Start	4.21	Rating **	M	Issue No.	42
LM End	4.21	Issue Type +	Ma	Location *	WS
Category	Earthen Levee			GPS Latitude/Longitude	
				Start	End
Item	Encroachments			39.163280 °	39.163280 °
				-121.894480 °	-121.894480 °
DWR ID	DWR_RD0070_01_s_2019_42				
Comment Code					
DE : Debris					
Inspector Comment					
The pile of debris should be removed from waterside toe.

View of the debris on the waterside slope.

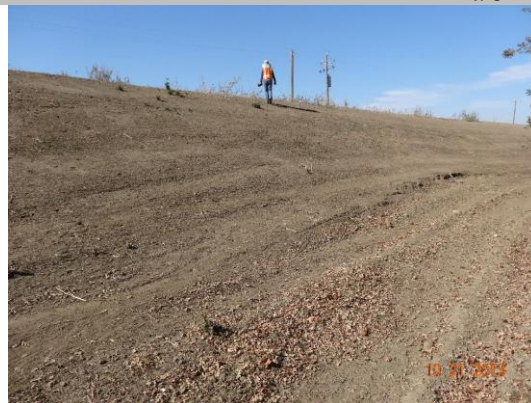
Photo 1 of 3 : UCIP_SP_2019_23515_40867.jpg

Comment Code					
Inspector Comment					
FS_ID:23515 DS_ID:21364 EP_NO: 9954 Repair Type: Non-Urgent Crossing Status: Found UCIP Comments: Power pole down on waterward side. Need to coordinate with owner to determine status of crossing. If crossing is no longer in use owner will need to contact the CVFPB to comply with Title 23. This crossing is referenced in the USACE Periodic Inspection as item USACE_CESPK_MRD1_2012_p_0147. FIELD_STRUCT_DESC: 18-inch (not 24-inch as referenced in the permit) steel irrigation discharge pipe through the levee, 18 feet below the crown. Pipe crosses the levee at a 45 degree angle. Slide gate in a 5-foot by 5-foot concrete box at the waterside (WS) toe. Pump in a pump house on the WS, not found. Discharge box at the landside (LS) toe. Power pole at the WS toe. (Retention of a 24-inch steel pipe through the levee, 18 feet below the crown, pump, slide gate, and discharge box authorized under Automatic Board Order (ABO) issued as Permit No. 9954, 1974 - Parker A. Reische). [Additional Reference(s): DWR Levee Log, 2007]. FS Date: 10/21/2013

View of waterward slope.

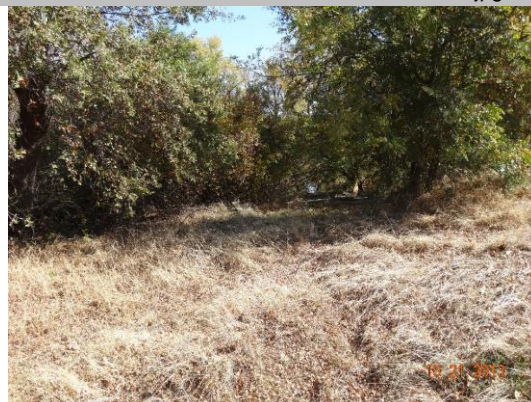
Photo 2 of 3 : UCIP_SP_2019_23515_40868.jpg

View of waterward side.

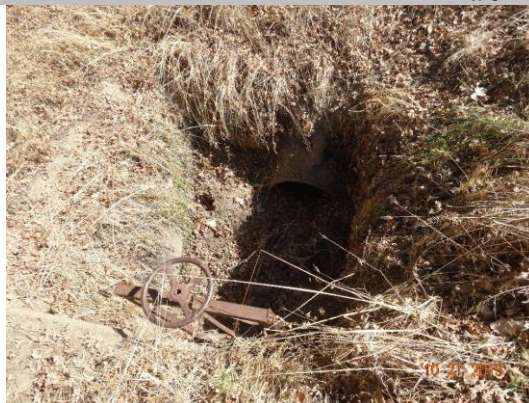
Photo 3 of 3 : UCIP_SP_2019_23515_40869.jpg

Comment Code						
Inspector Comment						
FS_ID:23515 DS_ID:21364 EP_NO: 9954 Repair Type: Non-Urgent Crossing Status: Found UCIP Comments: Power pole down on waterward side. Need to coordinate with owner to determine status of crossing. If crossing is no longer in use owner will need to contact the CVFPB to comply with Title 23. This crossing is referenced in the USACE Periodic Inspection as item USACE_CESPK_MRD1_2012_p_0147. FIELD_STRUCT_DESC: 18-inch (not 24-inch as referenced in the permit) steel irrigation discharge pipe through the levee, 18 feet below the crown. Pipe crosses the levee at a 45 degree angle. Slide gate in a 5-foot by 5-foot concrete box at the waterside (WS) toe. Pump in a pump house on the WS, not found. Discharge box at the landside (LS) toe. Power pole at the WS toe. (Retention of a 24-inch steel pipe through the levee, 18 feet below the crown, pump, slide gate, and discharge box authorized under Automatic Board Order (ABO) issued as Permit No. 9954, 1974 - Parker A. Reische). [Additional Reference(s): DWR Levee Log, 2007]. FS Date: 10/21/2013

View of concrete box located on waterward side, photo 2 of 2.

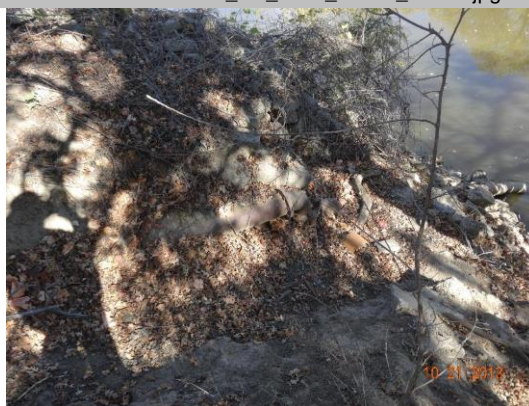
Photo 1 of 3 : UCIP_SP_2019_23516_40873.jpg

Comment Code						
Inspector Comment						
FS_ID:23516 DS_ID:21339 EP_NO: 9951 Repair Type: Non-Urgent Crossing Status: Found UCIP Comments: Need to coordinate with owner to determine status of crossing. If crossing is no longer in use owner will need to contact the CVFPB to comply with Title 23. This crossing is referenced in the USACE Periodic Inspection as item USACE_CESPK_MRD1_2012_p_0144. FIELD_STRUCT_DESC: 10-inch steel irrigation pipe through the levee, 16.3 feet below the crown. Pipe crosses the levee at a 45 degree angle. Siphon breaker in a corrugated metal pipe (CMP) riser on the landside (LS) slope. Gate valve on the waterside (WS) end. Pipe discharges into a concrete discharge box. (Plans to retain a 10-inch steel pipe through the levee, 16.3 feet below the crown, a gate valve, a siphon breaker in a CMP riser, and a concrete discharge box authorized under Automatic Board Order (ABO) issued as Permit No. 9951, 1974 - Frank and Mischa Pirtle). [Additional Reference(s): DWR Levee Log, 2007]. FS Date: 10/21/2013

View of pipe located on waterward side.

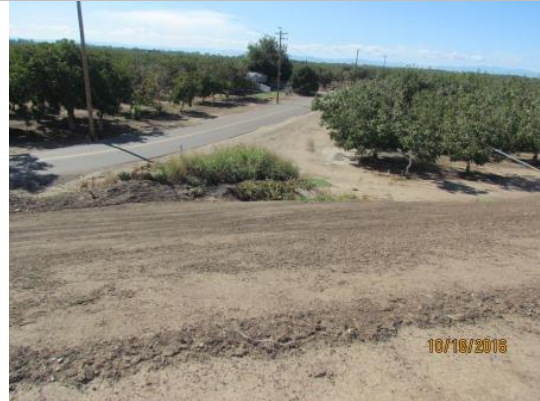
Photo 2 of 2 : SP_2019_RD0070_29_30_20190326_00006.jpg

LM Start	4.65	Rating **	M	Issue No.	30 (cont)	
LM End	4.65	Issue Type +	En	Location *	LS	
Category	Earthen Levee			GPS Latitude/Longitude		
				Start	End	
Item	Encroachments			39.168110 °	39.168110 °	
				-121.899910 °	-121.899910 °	
DWR ID	DWR_RD0070_01_f_2016_30					
Comment Code						
PR : Prunings						
Inspector Comment						
The prunings should be removed from the landside toe.

View of the prunings along the landside toe.

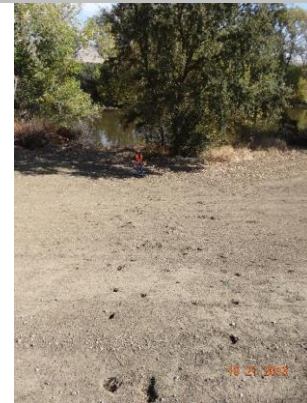
Photo 1 of 3 : UCIP_SP_2019_23517_40883.jpg

Comment Code						
Inspector Comment						
FS_ID:23517 DS_ID:21340 EP_NO: 9954 Repair Type: Non-Urgent Crossing Status: Found UCIP Comments: Burrow activity present on waterward slope. Need to coordinate with owner to determine status of crossing. If crossing is no longer in use owner will need to contact the CVFPB to comply with Title 23. This crossing is referenced in the USACE Periodic Inspection as item USACE_CESPK_MRD1_2012_p_0134. FIELD_STRUCT_DESC: 24-inch corrugated metal irrigation discharge pipe through the levee, 19 feet below the crown. Slide gate on the waterside (WS). Concrete distribution box at the landside (LS) toe. (Retention of a 24-inch corrugated metal pipe (CMP) through the levee, 19 feet below the crown, a slide gate, and a concrete distribution box authorized under Automatic Board Order (ABO) issued as Permit No. 9954, 1974 - Parker A. Reische). [Additional Reference(s): DWR Levee Log, 2007]. FS Date: 10/21/2013

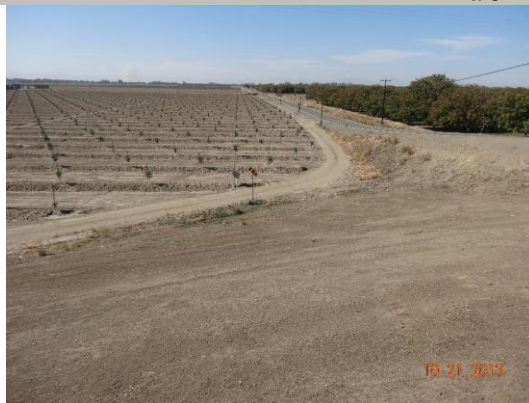
Photo 1 of 3 : UCIP_SP_2019_23479_40724.jpg

FS_ID:23479
 DS_ID:21360
 EP_NO: 4867
 Repair Type: Non-Urgent
 Crossing Status: Found
 UCIP Comments: Utility marker contact information includes Contact prior to Excavation call 1-800-227-2600 or Emergency Contact 1-800-811-4111. Need to contact owner to determine status of crossing. Need date of last inspection and confirmation that crossing is still in operable condition.
 FIELD_STRUCT_DESC: 6.5-inch coated steel natural gas pipeline through the levee, 4 feet below the crown. Concrete cutoff wall around the pipe at the center of the levee. Rock revetment on the waterside (WS) slope. (Plans for installing a gas line through the levee authorized under Permit No. 4867, 1965 - Pacific Gas and Electric Company [PG&E]). [Additional Reference(s): DWR Levee Log, 2007].
 FS Date: 10/21/2013

View of landward side.

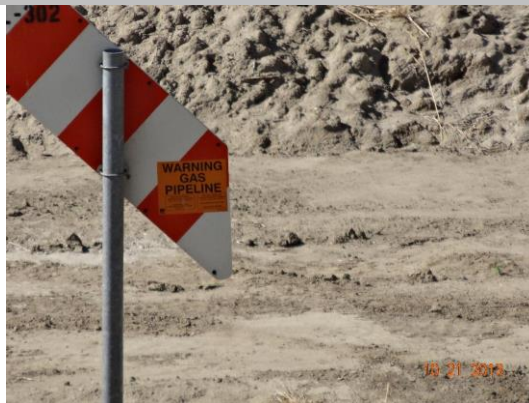
Photo 2 of 3 : UCIP_SP_2019_23479_40723.jpg

Pipeline marker on landward side.

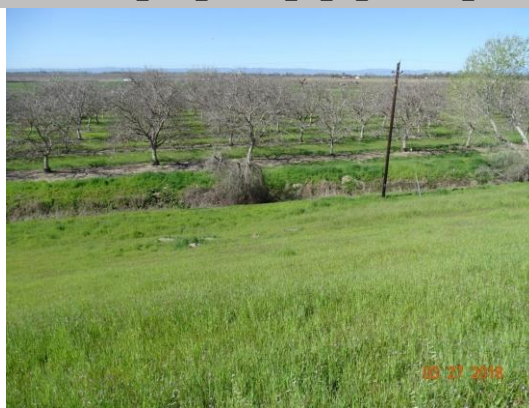
Photo 1 of 1 : SP_2019_RD0070_29_35_20190326_00009.jpg

LM Start	6.44	Rating **	M	Issue No.	35
LM End	6.44	Issue Type +	Ma	Location *	LS
Category	Earthen Levee			GPS Latitude/Longitude	
				Start	End
Item	Animal Control			39.190897 °	39.190897 °
				-121.912713 °	-121.912713 °
DWR ID	DWR_RD0070_01_s_2018_35				
Comment Code					
A3 : No rodents visible, but rodent burrows visible; need to backfill and compact or grout burrows.					
Inspector Comment

View of the rodent holes along the landside slope.

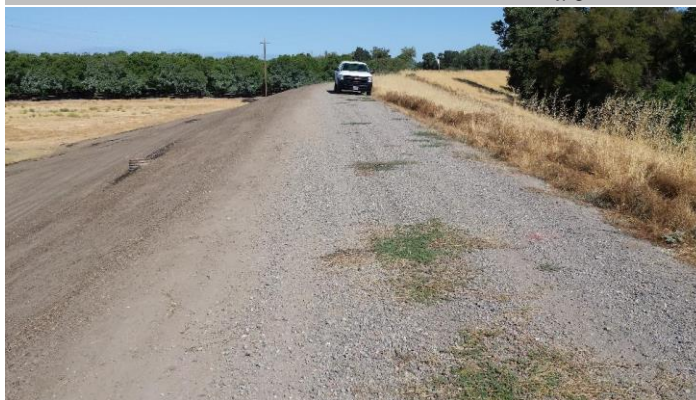
Photo 1 of 3 : UCIP_SP_2019_46422_74619.jpg

Comment Code						
Inspector Comment						
FS_ID:46422 DS_ID:21341 EP_NO: 9960 Repair Type: Non-Urgent Crossing Status: Found UCIP Comments: 07/28/2015 Pipe appears still appears abandoned. Priority was downgraded from Urgent to Non-Urgent due to the inactivity. Need to contact owner to confirm status and future use. If crossing is no longer in use owner will need to coordinate with DWR inspector and CVFPB to remove according to Title 23 requirements.10/21/2013 Hole present on pipe on waterward side. This crossing was determined urgent due to hole on pipe-no signs leaks present on waterward or landward slopes. Unable to find if crossing is being used. Need to contact owner to determine crossing is still in use. If crossing is no longer in use owner will need to coordinate with DWR inspector and CVFPB to remove according to Title 23 requirements. Unable to determine if crossing is in use. This crossing is referenced in the USACE Periodic Inspection as item USACE_CESPK_MRD1_2012_p_0069. FIELD_STRUCT_DESC: 12-inch steel pipe of an unknown purpose through the levee, 6.2 feet below the crown. Siphon breaker in a corrugated metal pipe (CMP) riser on the landside (LS) slope. Service pole on the LS shoulder. Concrete distribution box at the LS toe. (Retention of a 12-inch steel pipe through the levee, 6.2 feet below the crown, a siphon breaker in a CMP riser, a service pole, and a concrete distribution box authorized under Automatic Board Order (ABO) issued as Permit No. 9960, 1974 - Richard L. and Mildred E. Tarke). [Additional Reference(s): DWR Levee Log, 2007. USACE Sacramento O&M Manual 134, June 1953, (Station 332+72)]. FS Date: 7/28/2015 3:30:00 PM

Overview of levee crown at crossing. No change from last inspection.

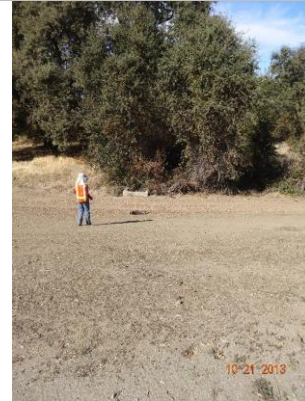
Photo 1 of 3 : UCIP_SP_2019_23529_40964.jpg

Comment Code						
Inspector Comment						
FS_ID:23529 DS_ID:21345 EP_NO: 9942 Repair Type: Non-Urgent Crossing Status: Found UCIP Comments: Dense vegetation limits the inspector's visibility to identify signs of pipe failure (leaks) along the slope. Recommend removing vegetation along pipe alignment to conduct proper inspection of structure and appurtenances. This crossing is referenced in the USACE Periodic Inspection as item USACE_CESPK_MRD1_2012_p_0005. FIELD_STRUCT_DESC: 24-inch corrugated metal irrigation discharge pipe through the levee, 16.5 feet below the crown. Incline pump on the waterside (WS). Slide gate in a corrugated metal pipe (CMP) riser on the WS slope. Pipe discharges into a concrete box at the landside (LS) toe. Service pole on the LS. (Retention of a 24-inch CMP through the levee, 16.5 feet below the crown, a slant pump, a slide gate in a CMP riser, a box, and a service pole authorized under Automatic Board Order (ABO) issued as Permit No. 9942, 1974 - R. W. and H. Evelyn Draper). [Additional Reference(s): DWR Levee Log, 2007. USACE Sacramento O&M Manual 134, June 1953, (Station 330+00)]. FS Date: 10/21/2013

View of waterward slope.

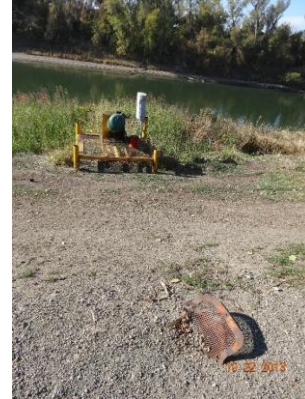
Photo 1 of 3 : UCIP_SP_2019_52618_42061.jpg

Comment Code					
Inspector Comment					
FS_ID:52618 DS_ID:21382 EP_NO: 12707 Repair Type: Urgent Crossing Status: Found UCIP Comments: 05/16/2018 2-foot round depression on waterward side found 4.5' from levee crown (Marty Rd). 14'x8'x3' excavation found on waterside slope to expose 14"-pipe. Evidence of internal erosion found at the bottom of excavation toward the pump. Cracks in asphalt pavement found on levee crown. (DWR UCIP - O.Yakimov) 11/03/2017 Crossing failed on WS and section of the levee was exposed to determine the extend of pipe damage by owner. Pipe is an up and over crossing. Crossing has been upgraded from Non-Urgent to Urgent due to pipe failure and exposed section of the levee visible on WS. (DWR UCIP - O. Magana)10/22/2013 Burrow activity noticed at this location. Crossing appurtenances have been modified. No 36-inch concrete distribution stand pipe present instead there is a concrete distribution box located at the landward toe. Also siphon breaker housing unit damage. Will need to contact owner. Need to obtain maintenance records and clarify modifications made at to crossing. Recommend having owner clear vegetation on waterward side. This crossing is referenced in the USACE Periodic Inspection as item USACE_CESPK_MRD2_2012_p_0018. FIELD_STRUCT_DESC: 14-inch coated steel irrigation discharge pipe through the levee, 3 feet below the crown. Steel cutoff wall around the pipe at the center of the levee. Pump on a metal platform (not timber as noted in the desk study) on the waterside (WS). Siphon breaker on the apex of the pipe at the WS shoulder. 36-inch concrete standpipe at the landside (LS) toe, not found during October 2013 inspection. Service pole at the LS toe. Rock revetment on the WS slope. (Plans to install a 30-kilowatt [40-horsepower] pump on the riverbank with a 14-inch steel discharge pipe through the levee authorized under Permit No. 12707, 1979 - Roger C. Wilber, Butte Creek Farms). [Additional Reference(s): DWR Levee Log, 2007]. FS Date: 5/16/2018

View of waterward side--siphon breaker housing unit, pipe daylight, pump, and platform.

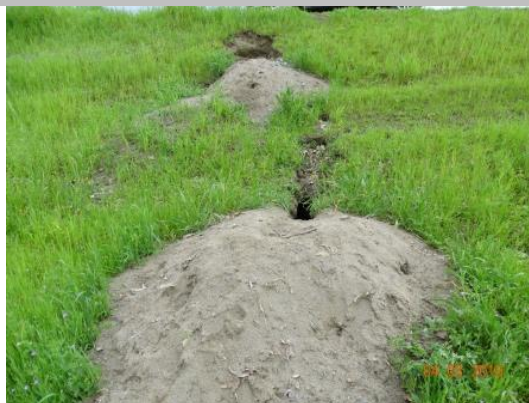
Photo 1 of 1 : SP_2019_RD0070_30_101_20190408_00140.jpg

LM Start	0.85	Rating **	U	Issue No.	101
LM End	0.85	Issue Type +	Ma	Location *	WS
Category	Earthen Levee			GPS Latitude/Longitude	
				Start	End
Item	Animal Control			39.185567 °	39.185567 °
				-121.941427 °	-121.941427 °
DWR ID	DWR_RD0070_02_s_2019_101				
Comment Code					
A3 : No rodents visible, but rodent burrows visible; need to backfill and compact or grout burrows.					
Inspector Comment

View of large rodent holes on the waterside slope. Spring 2019.

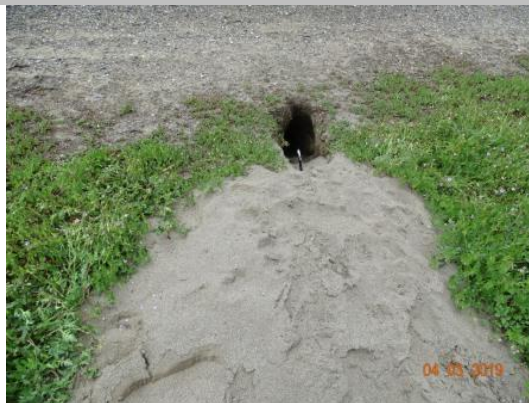
Photo 1 of 1 : SP_2019_RD0070_30_100_20190408_00139.jpg

LM Start	0.89	Rating **	U	Issue No.	100
LM End	0.89	Issue Type +	Ma	Location *	LS
Category	Earthen Levee			GPS Latitude/Longitude	
				Start	End
Item	Animal Control			39.185059 °	39.185059 °
				-121.941878 °	-121.941878 °
DWR ID	DWR_RD0070_02_s_2019_100				
Comment Code					
A3 : No rodents visible, but rodent burrows visible; need to backfill and compact or grout burrows.					
Inspector Comment

View of a large rodent burrow on the landside slope near the shoulder. Spring 2019.

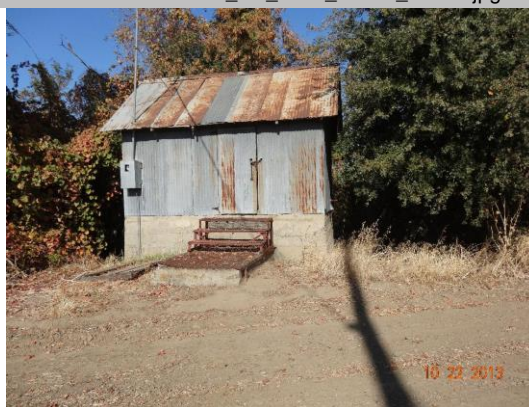
Photo 2 of 3 : UCIP_SP_2019_42923_42041.jpg

Pump station on waterward side.

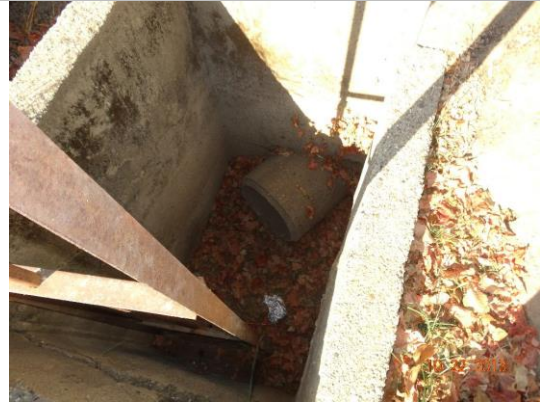
Photo 3 of 3 : UCIP_SP_2019_42923_42042.jpg

Comment Code						
Inspector Comment						
FS_ID:42923 DS_ID:21412 EP_NO: 1575 Repair Type: Non-Urgent Crossing Status: Found UCIP Comments: Debris scattered on waterward side. Concrete structure on waterward side shows major cracks on the walls. Will need to notify owner. Need to obtain maintenance records to confirm integrity of pipe. This crossing is referenced in the USACE Periodic Inspection as item USACE_CESPK_MRD2_2012_p_0075. FIELD_STRUCT_DESC: 20-inch steel irrigation discharge pipe through the levee, 17 feet below the crown. Pump and 10-inch slide gate in a pump house on the waterside (WS). Concrete collar at the WS toe. Power pole on the WS slope. Anchor on the landside (LS) slope. Rock revetment on the WS slope. (Plans for installing an irrigation pumping plant and a 20-inch discharge pipe through the levee authorized under Permit No. 1575, 1951 - Meridian Farms Water Company). [Additional Reference(s): DWR Levee Log, 2007]. FS Date: 10/23/2013

Inside view of concrete distribution box located on waterward side.

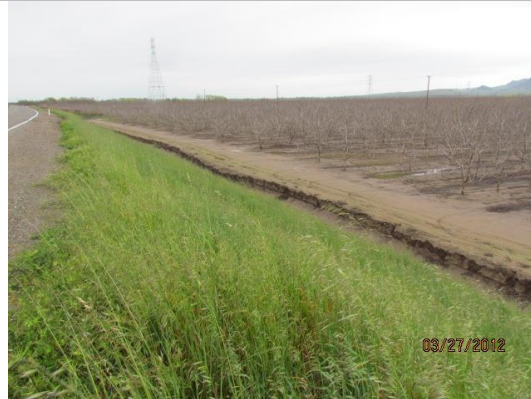
Photo 1 of 1 : SP_2019_RD0070_30_1_20190326_00001.jpg

LM Start	2.16	Rating **	M	Issue No.	1
LM End	2.32	Issue Type +	En	Location *	LS
Category	Earthen Levee			GPS Latitude/Longitude	
				Start	End
Item	Encroachments			39.168854 °	39.166503 °
				-121.936223 °	-121.935547 °
DWR ID	DWR_RD0070_02_s_2012_1				
Comment Code					
DT : Ditch					
Inspector Comment

Agricultural ditch along the landside toe.

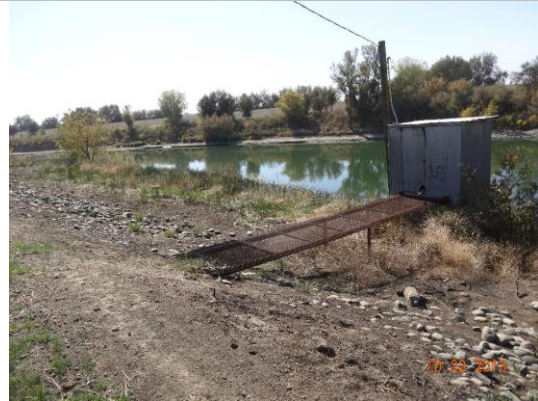
Photo 1 of 3 : UCIP_SP_2019_23891_41835.jpg

Comment Code						
Inspector Comment						
FS_ID:23891 DS_ID:21368 EP_NO: 9969 Repair Type: Non-Urgent Crossing Status: Found UCIP Comments: Landward slope too steep--need photo of the inside of concrete distribution box. Dense vegetation limits the inspector's visibility to identify signs of pipe failure (leaks) along the waterward slope. Recommend removing vegetation along pipe alignment to conduct proper inspection of structure and appurtenances. This crossing is referenced in the USACE Periodic Inspection as item USACE_CESPK_MRD2_2012_p_0158. FIELD_STRUCT_DESC: 20-inch (not 24-inch as mentioned in the permit) steel irrigation discharge pipe through the levee, 27 feet below the crown. Corrugated metal cutoff wall around the pipe at the center of the levee. Pump and gate valve in a pump house on the waterside (WS) slope. Pipe discharges into a concrete box at the landside (LS) toe. (Retention of a 24-inch steel pipe through the levee, 27 feet below the crown, a pump and gate valve, a concrete box, and a service pole authorized under Automatic Board Order (ABO) No. 9969, 1974 - Edwin J. and Vivian L. Burrows). [Additional Reference(s): DWR Levee Log, 2007. USACE Sacramento O&M Manual 134, June 1953, (Station 455+39), 24-inch listed]. FS Date: 10/22/2013

View of waterward side.

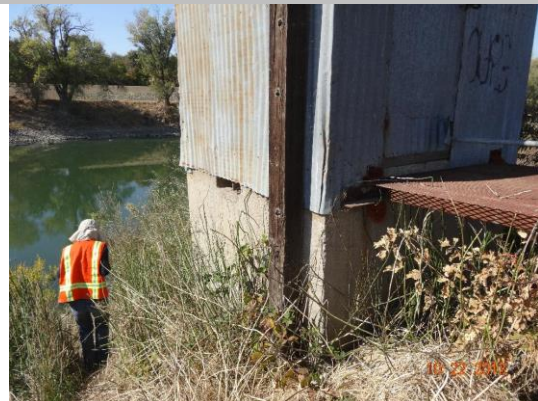
Photo 2 of 3 : UCIP_SP_2019_23891_41833.jpg

Pump station located on waterward side.

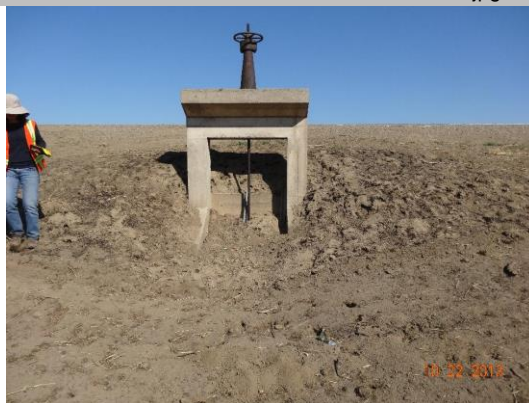
Photo 2 of 3 : UCIP_SP_2019_23892_41841.jpg

Buried screw gate located on waterward shoulder.

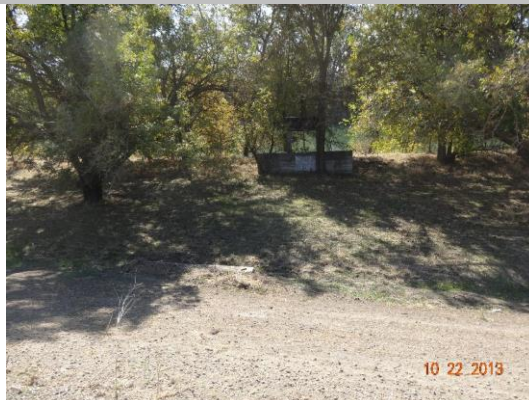
Photo 2 of 2 : UCIP_SP_2019_24117_42501.jpg

View of concrete headwall and screw gate on waterward side.

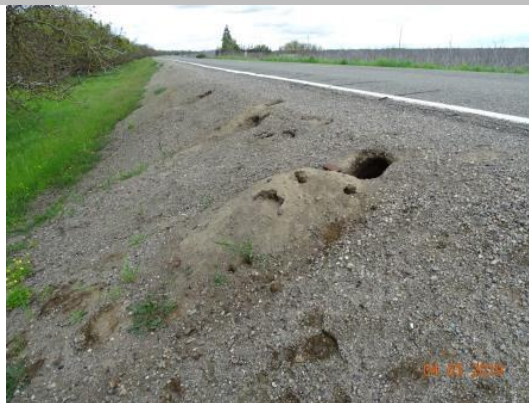
Photo 1 of 1 : SP_2019_RD0070_30_95_20190408_00135.jpg

LM Start	3.58	Rating **	U	Issue No.	95
LM End	3.58	Issue Type +	Ma	Location *	WS
Category	Earthen Levee			GPS Latitude/Longitude	
				Start	End
Item	Animal Control			39.154026 °	39.154026 °
				-121.920108 °	-121.920108 °
DWR ID	DWR_RD0070_02_s_2019_95				
Comment Code					
A3 : No rodents visible, but rodent burrows visible; need to backfill and compact or grout burrows.					
Inspector Comment

View of a large rodent burrow on the waterside slope/shoulder. Spring 2019.

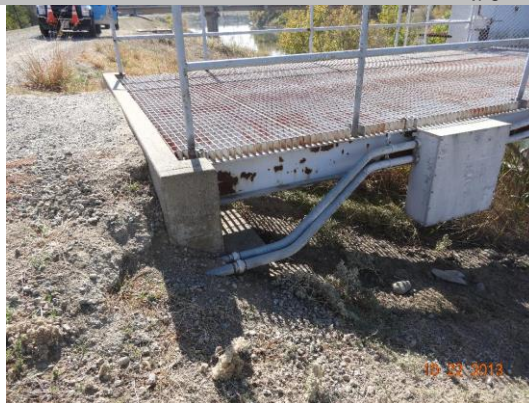
Photo 2 of 3 : UCIP_SP_2019_47030_42567.jpg

Comment Code						
Inspector Comment						
FS_ID:47030 DS_ID:21429 EP_NO: N/A Repair Type: Non-Urgent Crossing Status: Found UCIP Comments: Pump is to be demolished will all pipes removed. Will need to update record. This crossing is referenced in the USACE Periodic Inspection as item USACE_CESPK_MRD2_2012_p_0235. FIELD_STRUCT_DESC: [Meridian Farms Water Company Pumping Plant No. 1] 3 of 4: 42-inch steel irrigation discharge pipe and 2-inch polyvinyl chloride (PVC) electrical conduit through the levee, 24 and 3 feet below the crown, respectively. 42-inch pipe is concrete encased through the levee. Two concrete cutoff walls, one at each shoulder. Slide gate in a surge box on the waterside (WS). Concrete pump pit on the WS slope. Three pumps on a structure on the WS. Walkway to the pumps with an electrical control box. Concrete headwall on the landside (LS). Pipe discharges into a concrete lined irrigation ditch on the LS. Debris deflectors in the river. Power poles on the LS. (Plans to enlarge the Meridian Farms Water Company Pump Station Facility No. 1 by adding a 150-horsepower pump, a 42-inch water pipe, and a 2-inch electrical conduit through the levee authorized under Permit No. 13380, 1982 - Meridian Farms Water Company. Plans for existing pumping plant to be demolished with all pipes removed and replaced with a new Meridian Diversion pumping facility, two retractable fish screens, and a 72-inch gravity feed intake pipe under the levee authorized under Permit No. 18762, 2013 - Meridian Farms Water Company). [Additional Reference(s): DWR Levee Log, 2007]. FS Date: 10/22/2013

View of conduit pipes through levee.

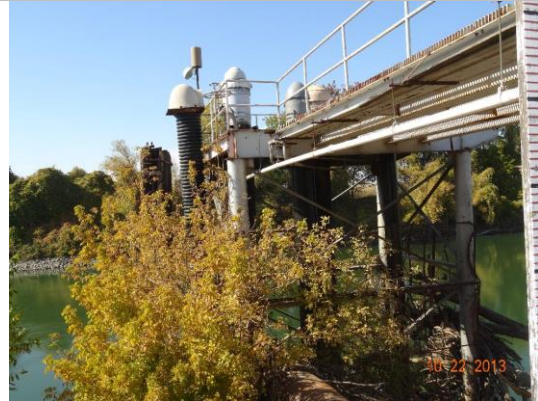
Photo 3 of 3 : UCIP_SP_2019_47030_42569.jpg

Comment Code						
Inspector Comment						
FS_ID:47030 DS_ID:21429 EP_NO: N/A Repair Type: Non-Urgent Crossing Status: Found UCIP Comments: Pump is to be demolished will all pipes removed. Will need to update record. This crossing is referenced in the USACE Periodic Inspection as item USACE_CESPK_MRD2_2012_p_0235. FIELD_STRUCT_DESC: [Meridian Farms Water Company Pumping Plant No. 1] 3 of 4: 42-inch steel irrigation discharge pipe and 2-inch polyvinyl chloride (PVC) electrical conduit through the levee, 24 and 3 feet below the crown, respectively. 42-inch pipe is concrete encased through the levee. Two concrete cutoff walls, one at each shoulder. Slide gate in a surge box on the waterside (WS). Concrete pump pit on the WS slope. Three pumps on a structure on the WS. Walkway to the pumps with an electrical control box. Concrete headwall on the landside (LS). Pipe discharges into a concrete lined irrigation ditch on the LS. Debris deflectors in the river. Power poles on the LS. (Plans to enlarge the Meridian Farms Water Company Pump Station Facility No. 1 by adding a 150-horsepower pump, a 42-inch water pipe, and a 2-inch electrical conduit through the levee authorized under Permit No. 13380, 1982 - Meridian Farms Water Company. Plans for existing pumping plant to be demolished with all pipes removed and replaced with a new Meridian Diversion pumping facility, two retractable fish screens, and a 72-inch gravity feed intake pipe under the levee authorized under Permit No. 18762, 2013 - Meridian Farms Water Company). [Additional Reference(s): DWR Levee Log, 2007]. FS Date: 10/22/2013

View of pumps located on waterward side.

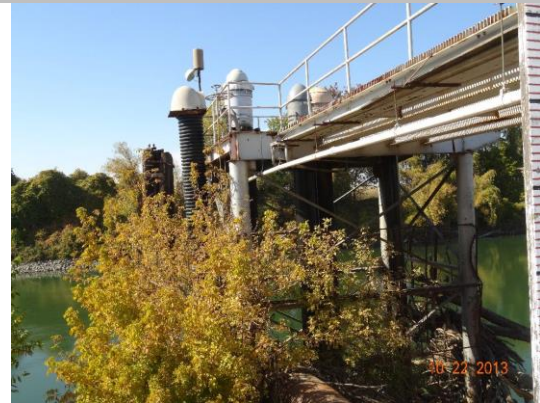
Photo 3 of 3 : UCIP_SP_2019_47032_42082.jpg

Item	DWR UCIP Field Study		39.147247 °	39.147247 °								
			-121.916691 °	-121.916691 °								
DWR ID	21373											
Comment Code												
Inspector Comment												
FS_ID:47032 DS_ID:21373 EP_NO: N/A Repair Type: Non-Urgent Crossing Status: Indicator Found UCIP Comments: Unable to confirm 54-inch pipe only found 42-inch pipe. Pump station is to be removed. Need to update record once crossing has been modified. This crossing is referenced in the USACE Periodic Inspection as item USACE_CESPK_MRD2_2012_p_0235. FIELD_STRUCT_DESC: [Meridian Farms Water Company Pumping Plant No. 2] 4 of 4: 54-inch steel irrigation discharge pipe through the levee, 24 feet below the crown. Pipe is concrete encased through the levee. Two concrete cutoff walls, one at each shoulder. Slide gate in a surge box on the waterside (WS). Concrete pump pit on the WS slope. Three pumps on a structure on the WS. Walkway to the pumps. Concrete headwall on the landside (LS). Pipe discharges into a concrete lined irrigation ditch on the LS. Debris deflectors in the river. (Plans for construction of a pumping plant and related facilities to replace an existing plant on the left bank of the Sacramento River authorized under Permit No. 4525, 1964 - Meridian Farms Water Company. Plans for existing pumping plant to be demolished with all pipes removed and replaced with a new Meridian Diversion pumping facility, two retractable fish screens, and a 72-inch gravity feed intake pipe under the levee authorized under Permit No. 18762, 2013 - Meridian Farms Water Company). [Additional Reference(s): DWR Levee Log, 2007]. FS Date: 10/22/2013

View of pumps located on waterward side.

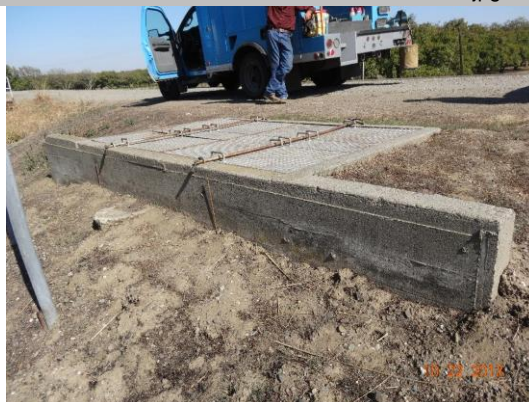
Photo 2 of 3 : UCIP_SP_2019_24165_42575.jpg

Concrete headwall on waterward side.

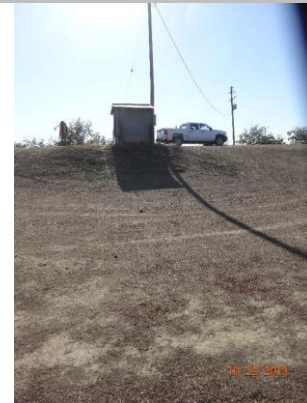
Photo 1 of 3 : UCIP_SP_2019_24166_42581.jpg

Comment Code					
Inspector Comment					
FS_ID:24166 DS_ID:21380 EP_NO: 9970 Repair Type: Non-Urgent Crossing Status: Found UCIP Comments: Need to coordinate with owner to determine status of crossing. No pump is located inside the pump house located on waterward side. If crossing is no longer in use owner will need to contact the CVFPB to comply with Title 23. Dense vegetation limits the inspector's visibility to identify signs of pipe failure (leaks) along the slope. Recommend removing vegetation along pipe alignment to conduct proper inspection of structure and appurtenances. This crossing is referenced in the USACE Periodic Inspection as item USACE_CESPK_MRD2_2012_p_0274. FIELD_STRUCT_DESC: 10-inch steel irrigation discharge pipe through the levee, 4.8 feet below the crown. Corrugated metal cutoff wall around the pipe at the center of the levee. Siphon breaker on the landside (LS) slope, not found. Pump in a pump house on the waterside (WS) shoulder. Shutoff valve on the LS. Concrete discharge box at the LS toe. (Retention of a 10-inch steel pipe through the levee, 4.8 feet below the crown, a pump, a service pole, a siphon breaker, and a concrete discharge box authorized under Automatic Board Order (ABO) issued as Permit No. 9970, 1974 - Arnold Chesini). [Additional Reference(s): DWR Levee Log, 2007. USACE Sacramento O&M Manual 134, June 1953, (Station 526+71)]. FS Date: 10/22/2013

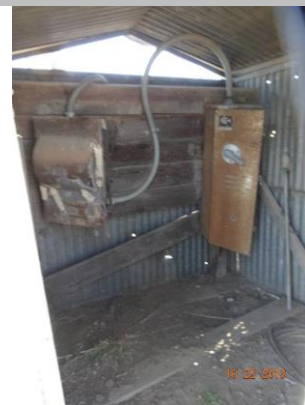
Photo 3 of 3 : UCIP_SP_2019_24166_42583.jpg

View of the inside of pump house--no pump.

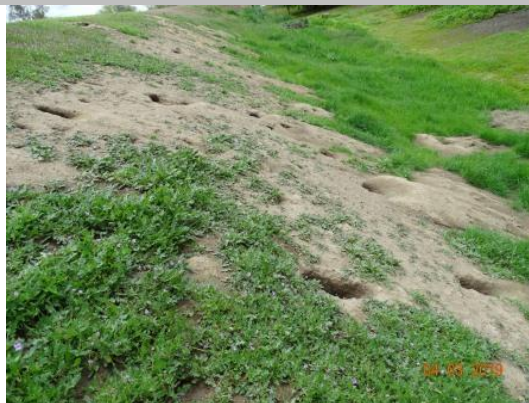
Photo 2 of 3 : SP_2019_RD0070_30_89_20190408_00130.jpg

LM Start	5.03	Rating **	U	Issue No.	89 (cont)	
LM End	5.08	Issue Type +	Ma	Location *	LS	
Category	Earthen Levee			GPS Latitude/Longitude		
				Start		End
Item	Animal Control			39.141997 °		39.141905 °
				-121.927776 °		-121.928654 °
DWR ID	DWR_RD0070_02_s_2019_89					
Comment Code						
A3 : No rodents visible, but rodent burrows visible; need to backfill and compact or grout burrows.						
Inspector Comment

Another view of the rodent burrows on the landside slope. Spring 2019.

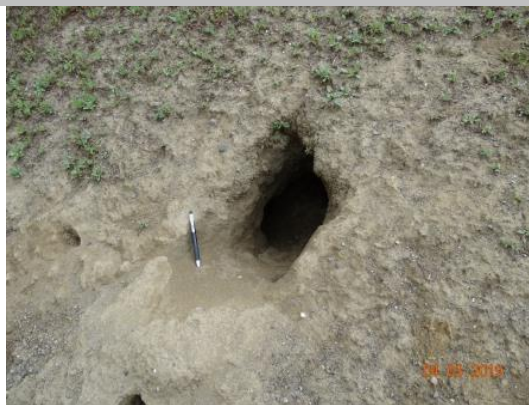
Photo 3 of 3 : SP_2019_RD0070_30_89_20190408_00131.jpg

LM Start	5.03	Rating **	U	Issue No.	89 (cont)
LM End	5.08	Issue Type +	Ma	Location *	LS

Upclose view of a large rodent burrow. Spring 2019.

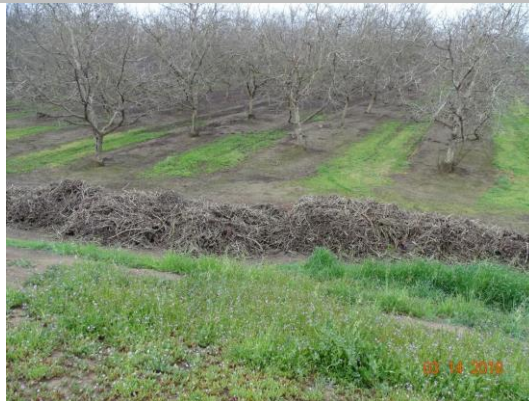
Photo 1 of 1 : SP_2019_RD0070_30_47_20190326_00003.jpg

LM Start	5.08	Rating **	M	Issue No.	47
LM End	5.08	Issue Type +	En	Location *	LS
Category	Earthen Levee			GPS Latitude/Longitude	
				Start	End
Item	Encroachments			39.141938 °	39.141938 °
				-121.928597 °	-121.928597 °
DWR ID	DWR_RD0070_02_s_2018_47				
Comment Code					
PR : Prunings					
Inspector Comment					
The prunings should be removed from the landside toe.

View of the prunings along the landside toe.

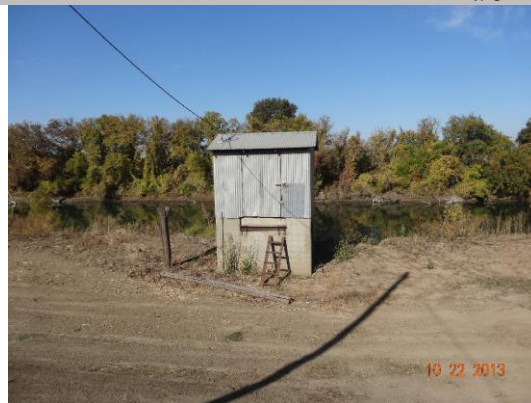
Photo 1 of 3 : UCIP_SP_2019_23964_42114.jpg

Comment Code					
Inspector Comment					
FS_ID:23964 DS_ID:21383 EP_NO: 9984 Repair Type: Non-Urgent Crossing Status: Found UCIP Comments: Will need to contact owner. Need to obtain maintenance records and clarify modifications made at to crossing (size). Additional crossing visible through concrete headwall on landward side--crossing has been capped (see photo). NEED TO CONFIRM PIPE SIZE!!! This crossing is referenced in the USACE Periodic Inspection as item USACE_CESPK_MRD2_2012_p_0289. FIELD_STRUCT_DESC: 12-inch steel irrigation discharge pipe (not 24-inch, as referenced in the permit) through the levee, 13.8 feet below the crown. Gate valve on the waterside (WS). Pump in a pump house on the WS. Concrete distribution box at the landside (LS) toe. (Retention of a 24-inch steel pipe through the levee, 13.8 feet below the crown, a pump, a gate valve, and a concrete distribution box authorized under Automatic Board Order (ABO) issued as Permit No. 9984, 1974 - Edward E. and Alice B. Lemos, et al.). [Additional Reference(s): DWR Levee Log, 2007. USACE Sacramento O&M Manual 134, June 1953, (Station 555+09), 24-inch listed]. FS Date: 10/22/2013

Pump house located on waterward side.

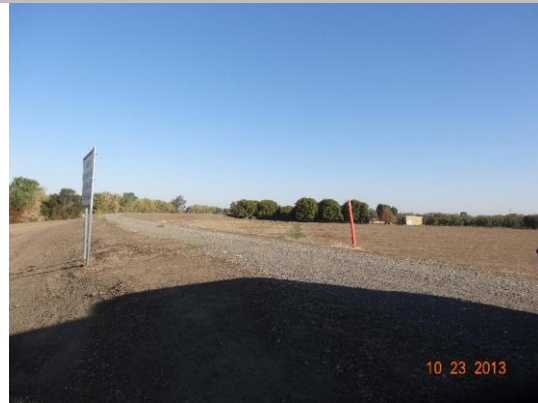
Photo 1 of 3 : UCIP_SP_2019_23965_42123.jpg

Comment Code					
Inspector Comment					
FS_ID:23965 DS_ID:21385 EP_NO: 4383 Repair Type: Non-Urgent Crossing Status: Found UCIP Comments: Need to contact owner to determine if crossing is still active and to determine last inspection date. Will need copy of letter showing crossings passed inspection. This crossing is referenced in the USACE Periodic Inspection as item USACE_CESPK_MRD2_2012_p_0319. FIELD_STRUCT_DESC: 8.625-inch steel natural gas pipeline through the levee, 3.5 feet below the crown. Concrete cutoff wall around the pipe at the center of the levee. Rock revetment on the waterside (WS) slope. (Plans for construction, maintenance, and use of an 8.625-inch gas line authorized under Permit No. 4383, 1963 - Pacific Gas and Electric Company [PG&E]). [Additional Reference(s): DWR Levee Log, 2007]. FS Date: 10/23/2013

Markers visible on both levee shoulders.

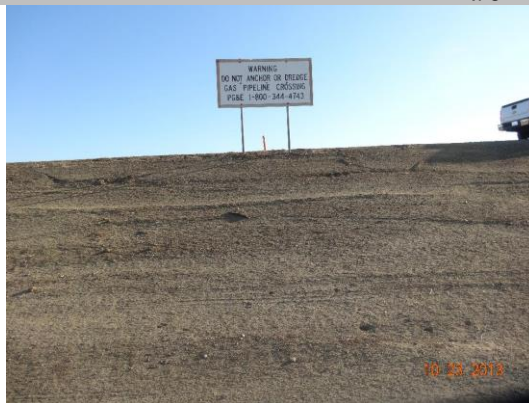
Photo 2 of 3 : UCIP_SP_2019_23965_42121.jpg

Comment Code					
Inspector Comment					
FS_ID:23965 DS_ID:21385 EP_NO: 4383 Repair Type: Non-Urgent Crossing Status: Found UCIP Comments: Need to contact owner to determine if crossing is still active and to determine last inspection date. Will need copy of letter showing crossings passed inspection. This crossing is referenced in the USACE Periodic Inspection as item USACE_CESPK_MRD2_2012_p_0319. FIELD_STRUCT_DESC: 8.625-inch steel natural gas pipeline through the levee, 3.5 feet below the crown. Concrete cutoff wall around the pipe at the center of the levee. Rock revetment on the waterside (WS) slope. (Plans for construction, maintenance, and use of an 8.625-inch gas line authorized under Permit No. 4383, 1963 - Pacific Gas and Electric Company [PG&E]). [Additional Reference(s): DWR Levee Log, 2007]. FS Date: 10/23/2013

View of waterward slope.

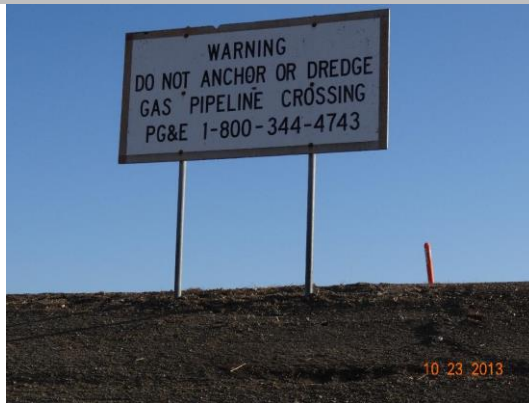
Photo 3 of 3 : UCIP_SP_2019_23965_42122.jpg

Sign visible on waterward side.

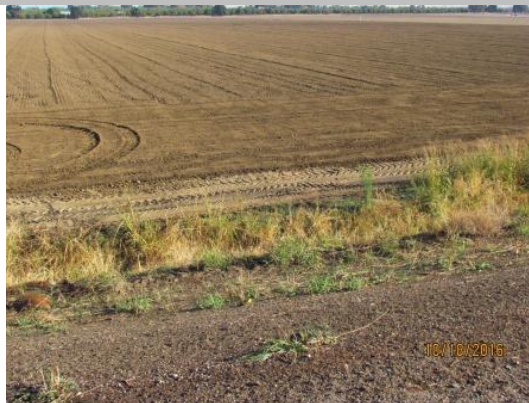
Photo 1 of 1 : SP_2019_RD0070_30_56_20190326_00006.jpg

LM Start	6.32	Rating **	M	Issue No.	56
LM End	7.09	Issue Type +	En	Location *	LS
Category	Earthen Levee			GPS Latitude/Longitude	
				Start	End
Item	Encroachments			39.133450 °	39.129024 °
				-121.937361 °	-121.924632 °
DWR ID	DWR_RD0070_02_f_2016_56				
Comment Code					
DT : Ditch					
Inspector Comment

View of a ditch at the landside toe.

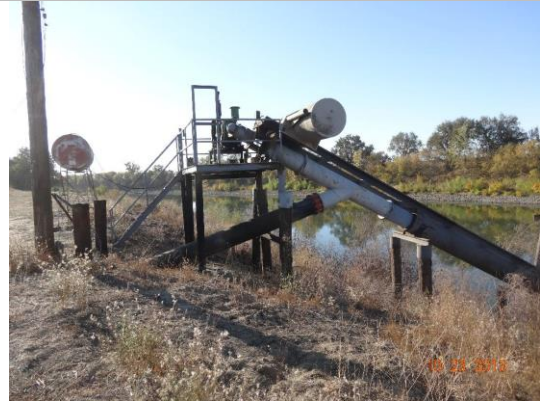
Photo 2 of 3 : UCIP_SP_2019_46424_42049.jpg

FS_ID:46424
 DS_ID:21386
 EP_NO: 9994
 Repair Type: Non-Urgent
 Crossing Status: Found
 UCIP Comments: 07/28/2015 System was running during site visit. Damage to landward side has been repaired. No records available to determine cause of erosion--monitor. No other issues observed during site visit. 10/23/2013 Erosion visible on landward side behind concrete headwall. Plastic sheeting has been placed to protect slope. Need to determine cause for erosion, is pipe leaking? Pipe wall on landward side has deteriorated significantly that the wall is gone. Owner will need to coordinate with DWR inspector and CVFPB to address issue. Recommend notifying owner to stop using crossing until issue has been addressed. This crossing is referenced in the USACE Periodic Inspection as item USACE_CESPK_MRD2_2012_p_0324.
 FIELD_STRUCT_DESC: 20-inch coated steel irrigation discharge pipe on the waterside (WS) and 24-inch coated steel irrigation discharge pipe on the landside (LS) through the levee, 12.5 feet below the crown. Pipe is concrete encased under the crown, between the shoulders. Slide gate in a metal well on the WS slope. Pump on a pile structure in the stream. Concrete discharge box at the LS toe. Service pole on the WS slope. (Plans for the installation of an irrigation pumping plant and appurtenant electrical power line across the levee authorized under Permit No. 1202, 19 - Hannah R. Jacobs. Retention of a 24-inch concrete encased steel pipe through the levee, 12.5 feet below the crown, a pump, a slide gate, and a concrete discharge box authorized under Automatic Board Order (ABO) issued as Permit No. 9994, 1974 - R. X. Ranch Company). [Additional Reference(s): DWR Levee Log, 2007. USACE Sacramento O&M Manual 134, June 1953, (Station 610+84)].

Pipe and pump set up on waterward side.

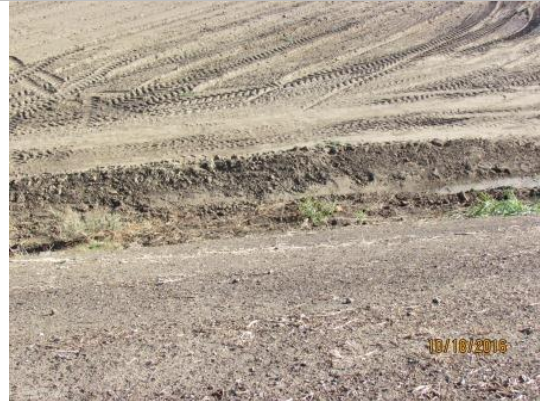
Photo 1 of 1 : SP_2019_RD0070_30_57_20190326_00007.jpg

LM Start	7.18	Rating **	M	Issue No.	57
LM End	7.18	Issue Type +	En	Location *	LS
Category	Earthen Levee			GPS Latitude/Longitude	
				Start	End
Item	Encroachments			39.128114 °	39.128114 °
				-121.923429 °	-121.923429 °
DWR ID	DWR_RD0070_02_f _ 2016_57				
Comment Code					
DT : Ditch					
Inspector Comment

View of a ditch along the landside toe.

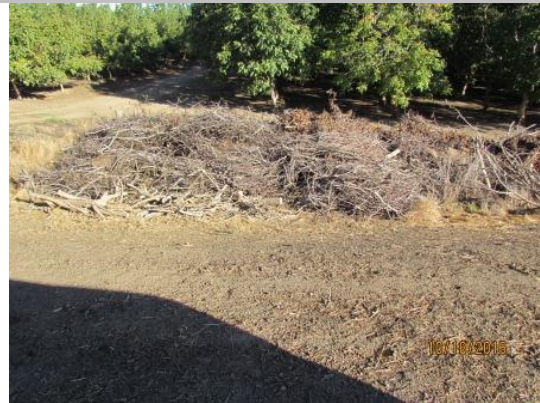
Photo 1 of 1 : SP_2019_RD0070_30_58_20190326_00008.jpg

LM Start	7.62	Rating **	M	Issue No.	58
LM End	7.64	Issue Type +	En	Location *	LS
Category	Earthen Levee			GPS Latitude/Longitude	
				Start	End
Item	Encroachments			39.124448 °	39.124493 °
				-121.917505 °	-121.917090 °
DWR ID	DWR_RD0070_02_f_2016_58				
Comment Code					
PR : Prunings					
Inspector Comment					
Remove prunings from the landside toe.

View of the prunings along the landside toe.
